Strengthening Civil Society Through Community Development in Ribnita

GREEN COMMUNITY CENTER Feasibility Study

by Balázs Nagy

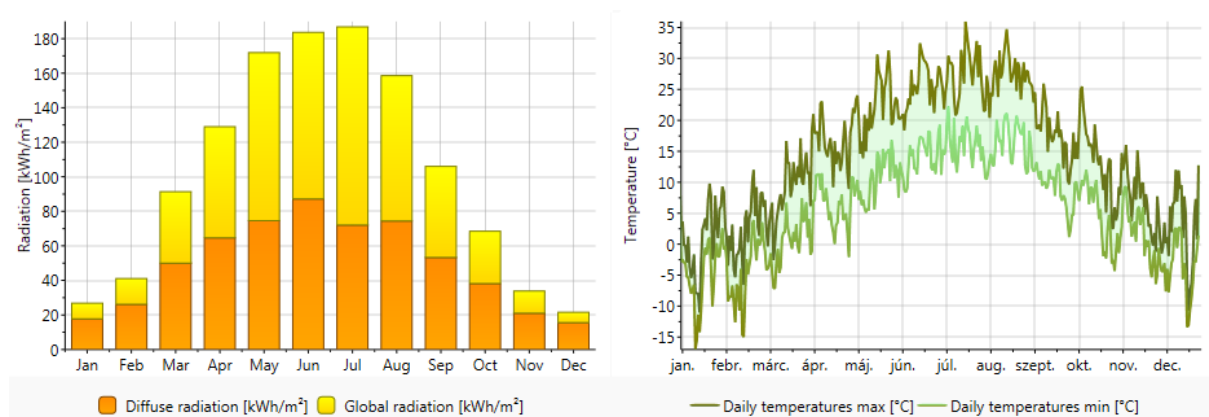
The daily sunshine duration is low in the heating (winter) season, a 3 hours average in October to March. There are three times more solar radiation in the cooling (summer) season, than in the cooling season. The global horizontal irradiation ranges from 22 kWh/m² in December to 187 kWh/m² in July. As shown in the second figure, the the proportion of diffuse radiation in the winter months are higher. Based on the interpolated data, the solar gains can be useful and usable for active or passive utilization in Ribnita.

2. figure: Left: Monthly distribution of radiation, Right: Daily temperature extremes in Ribnita

The wind speed the wind speed is average, during the winter months a little more significant than in summer. Based on the monthly data, the utilization of wind energy in Ribnita is considered a risky investment because of a year-round average wind speeds below 3 m/s.

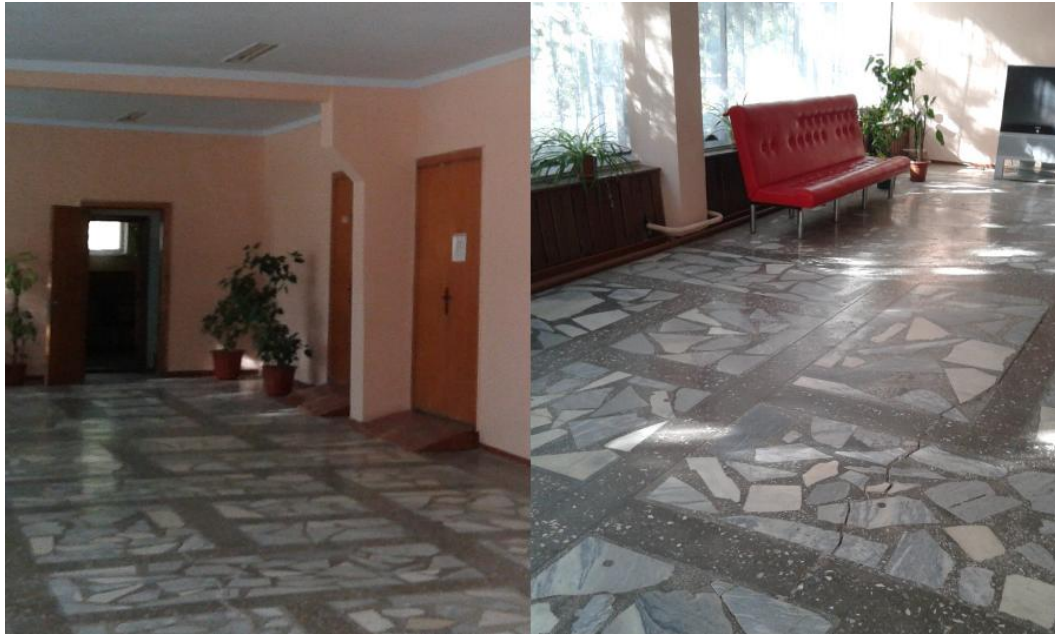
The floor of the lobby is made of gravel concrete with natural stone decorative insertions. The floor presents a serious horizontal dilatation crack, which may have been caused by the different thermal loading of the floor or even by the sinking of the building’s northern side.

The floor of this part of the building is located 10 cm-s below the level of the floor in the hall structures, accessibility being solved using ramps. At the edges of the building, near the reinforced concrete columns the joints of these columns with the flooring presented signs of wetting, which suggests inadequate waterproofing. Montage of waterproofing and thermal

7. figure: Floor of the entrance hall

insulation on the existing flooring system is recommended, which may also help in the elimination of the level difference. Before any intervention we have to verify the current state of the floor structure with destructive methods, in order to find out more about the layers present there and to investigate the source of the longitudinal crack found on the floor.

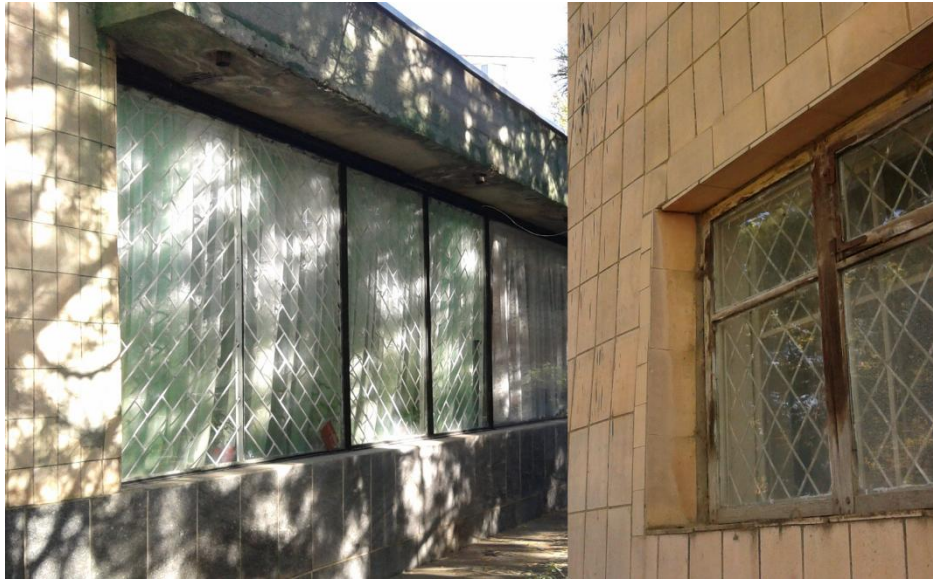
Moreover, large windows can also be found on the southern side of the building, these windows having an important role in the natural lighting of the gym, while the direct radiation gains getting through the glass reduce the energy needed for heating in the transition period. Again, the problem consists in the technic and qualitative state of these windows. The paintwork of the wooden frame holding the one-layer glazing has peeled off, while the joints are also defective.

On the northern side of the building three window-openings can be found, but in the case of two of these the windows are covered with gypsum sheets on the exterior side. As such, natural diffuse light does not enter the dressing rooms that are provided with this solution. Another filled window opening can be found in one of the first floor rooms that is oriented to the east. In this case the opening was filled with small-sized solid bricks. The interior doors are also made of timber, the sills are quite high in all of the cases. Some of the rooms of the buildings have accessibility issues.

10. figure: Windows with steel or wood frames

All summed up, we can state that the current location of the windows satisfies the requirements of a green community centre, while the replacement of the existing components is essential not only for energy-efficiency reasons, but also to ensure fundamental operation conditions.

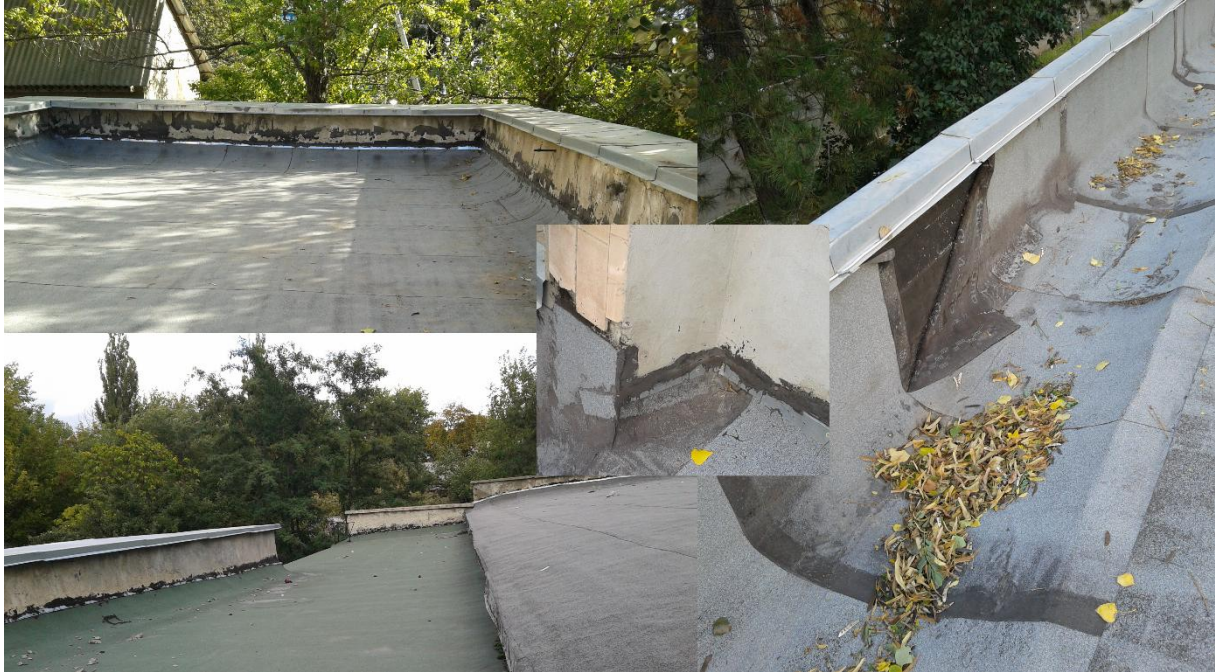
The bituminous sheets show signs of aging, the execution is of low quality, the joints are inaccurate. In many places the sheets have detached from the surface. The joints of the bituminous sheets at the attic is amateurishly executed, the metallic sheets were positioned over the bituminous sheets and the fastenings penetrate through both the metallic and the

bituminous sheet. In some places the waterproofing sheets are fixed on the vertical walls only with bituminous glue, the execution of the corners is of sub-standard quality. The drainage system is inadequate, the slope of the roof being in many cases unsatisfactory. The waterproofing of the buildings parts having different height is not linked.

11. figure: Image compilation about the condition of the roof

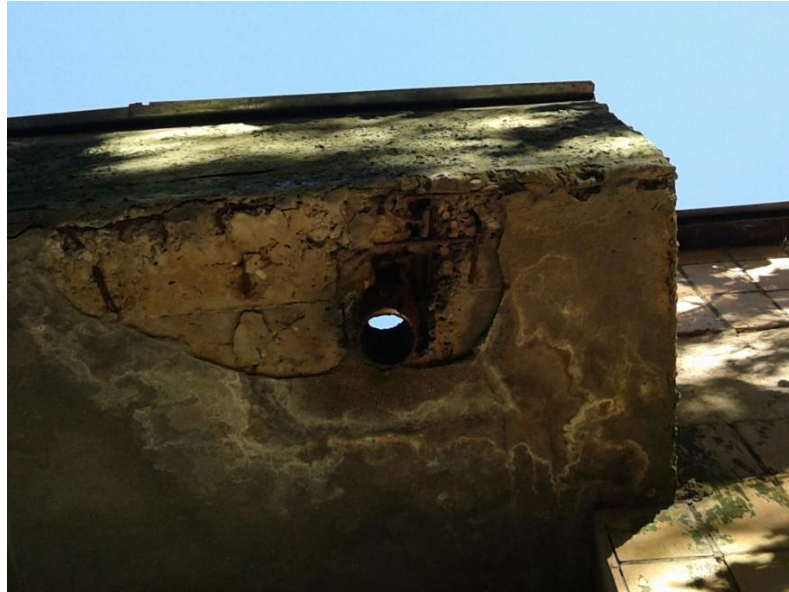
The attic, and subsequently the drainage is missing in many places around the perimeter of the roof. The absence of the attic is inadequate for safety reasons also. The interior-side surface of the attics is in most of the cases plastered, the application of the waterproofing onto this surface has only been done on the lobby building section, but even here the waterproofing has only been fixed to the surface. Because of this the bituminous sheet has detached from the surface. The metallic sheet coating of the attics is deficient, even where this is present, the fastenings are inadequate, as penetrative fixing was used, which also induces leakage.

12. figure: Corroded drainage opening

The gutter system is also inadequate. Because of this the slabs are severely damaged in the areas neighbouring drainage elements. The areas of the slabs in the vicinity of these elements need to be repaired, as the reinforcements of the RC elements are severely corroded, while the concrete cover is missing.

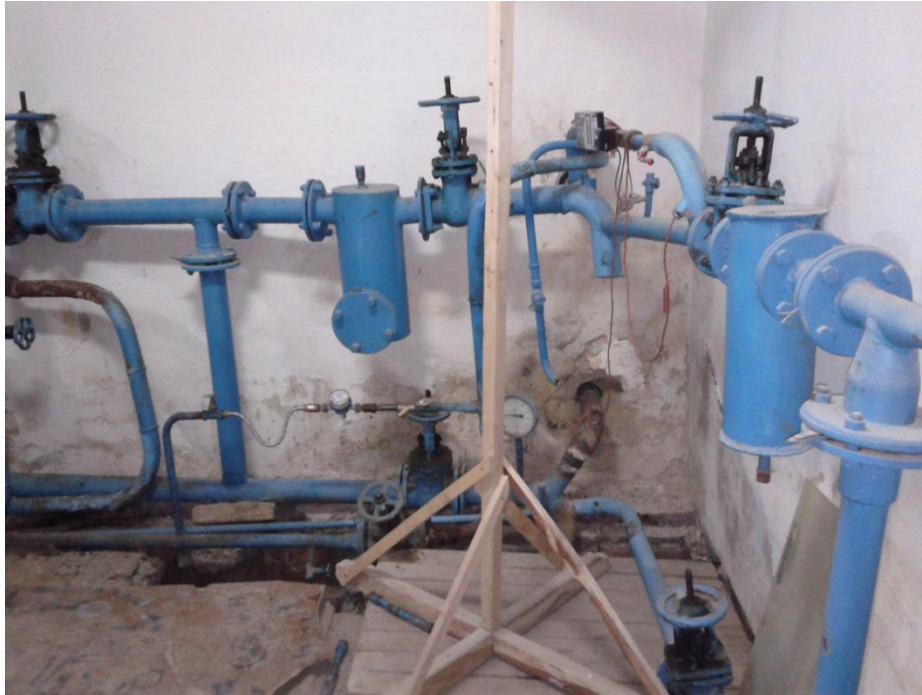
Inside the building, the internal piping runs in the heated space. In fact, in many places the heating of the rooms is done not using radiators, but by the distribution pipes only. The piping runs freely even in the areas not meant to be heated, there is no thermal insulation the pipes in these spaces. Many of the pipes are corroded and in bad condition. In some of the places the pipes represent obstacles in the rooms and reduce the free cross-section of the corridors.

In the spaces intended to be heated cast iron radiators can be found. In the lobby area, the radiators are located near the parapet walls of the façade, in order to be able to dry the moisture that condensates on the large glazing surface. We have found no adjustment valves on the radiators.

13. figure: District heating pipes in the mechanical room

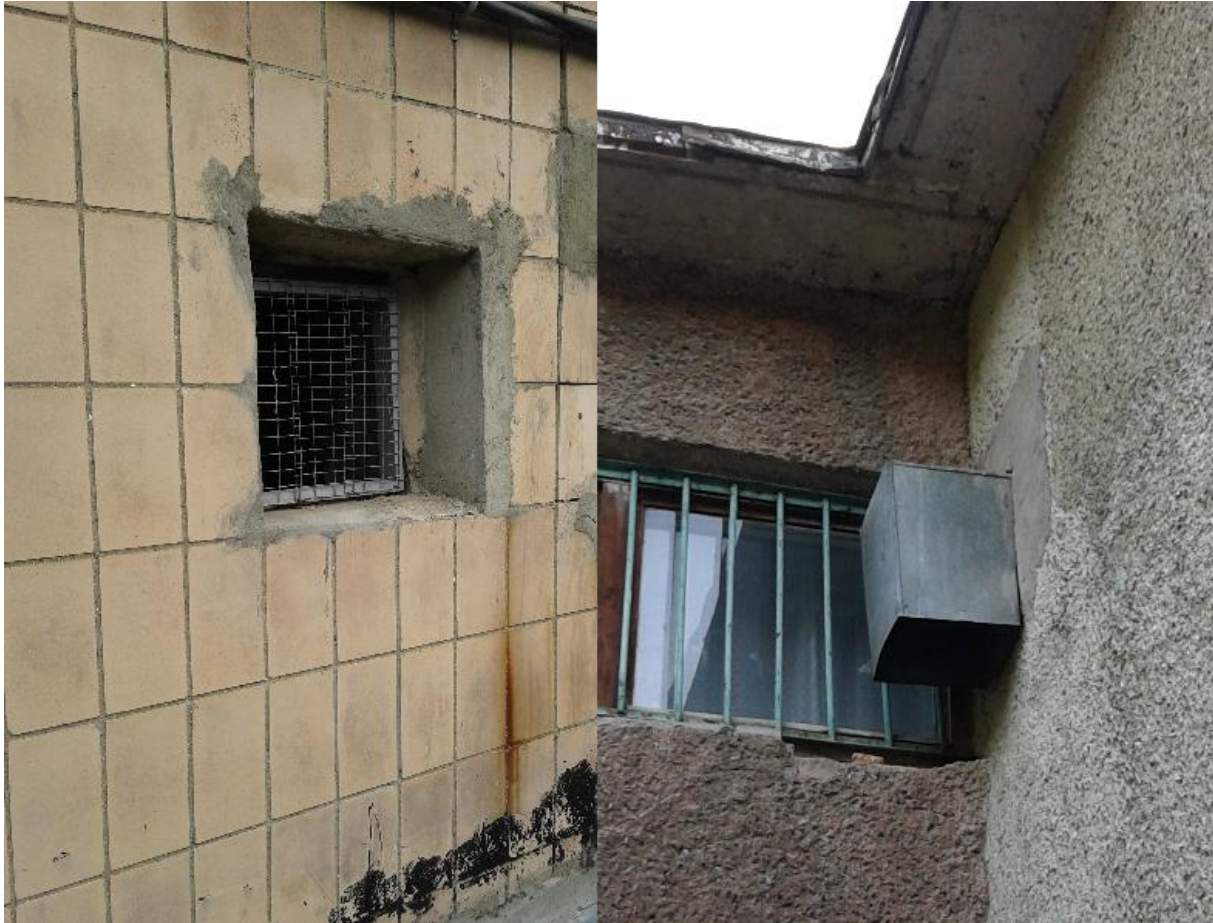
The ventilation of the theatre hall is assured by an open ventilation duct. This runs directly from the western to the eastern façade on the first floor and has internal openings at the theatre hall, where fresh air can enter the space. The ventilation system seemed neglected, the duct was dirty and showed signs of lacking maintenance. On the western façade the duct is separated from the outside environment by a metallic net, protection against rainfall or snow is not solved. On the eastern side a metal cover box was installed. The vents cannot be closed. In the case of the open ending on the western side, the watering of the neighbouring areas is probably caused by the vent's lack of covering.

14. figure: Ventillation openings

If we decide to keep the original ventilation concept, the condition of these openings has to be improved, they have to be modified. The openings have to be provided with a fan and a closable latch, improving thus the efficiency and reducing the losses when there is no need for ventilation. Due to the current design the heat losses caused by the ventilation cannot be limited.

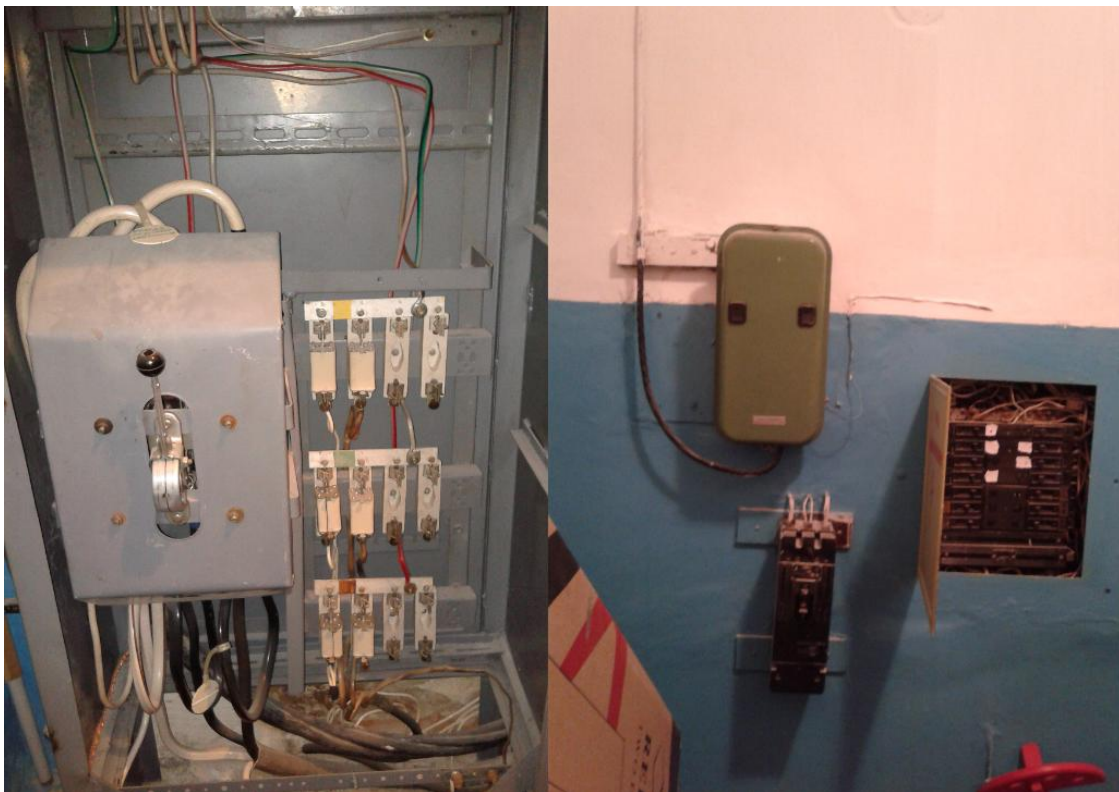
The building is connected to the power grid via an air cable at its north-eastern corner and there is an electric transformer building immediately near the youth centre. The room containing the electric distribution system is located in the building section between the theatre hall and the gym, in the proximity of the sanitary area and the stairs. The electric switch cabinet is old and in very bad condition, the fuses and the state of the electric system is also inadequate. The electric plug sockets lack grounding, the electric wires in the building are old. The replacement of the electric network located in the building is required.

15. figure: Electric equipments and fuse box

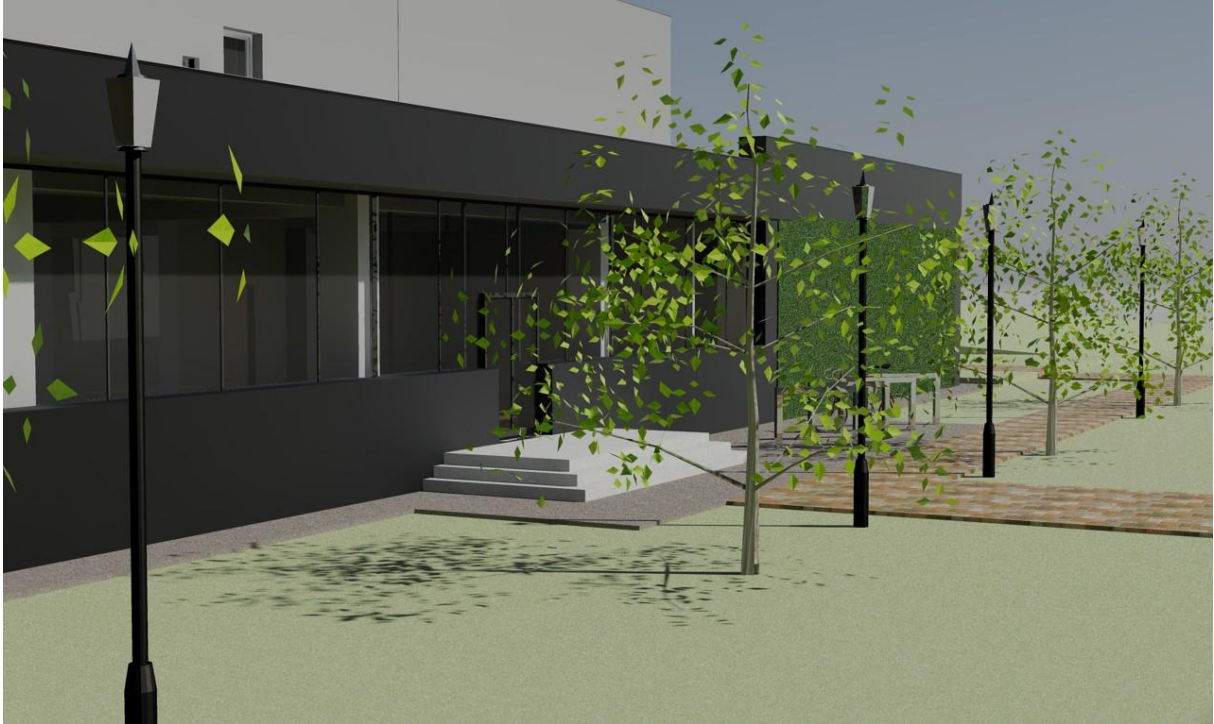
21. figure: South facace, A variant

22. figure: Rooftop view from South-East, A variant

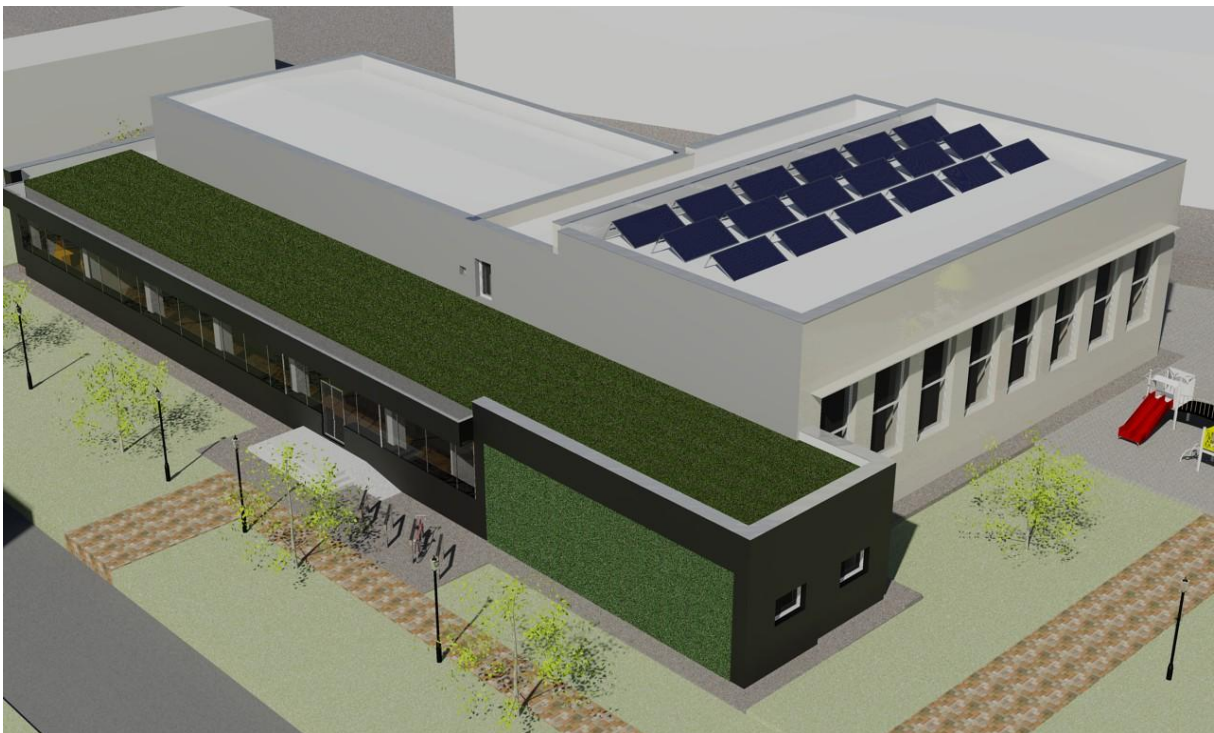
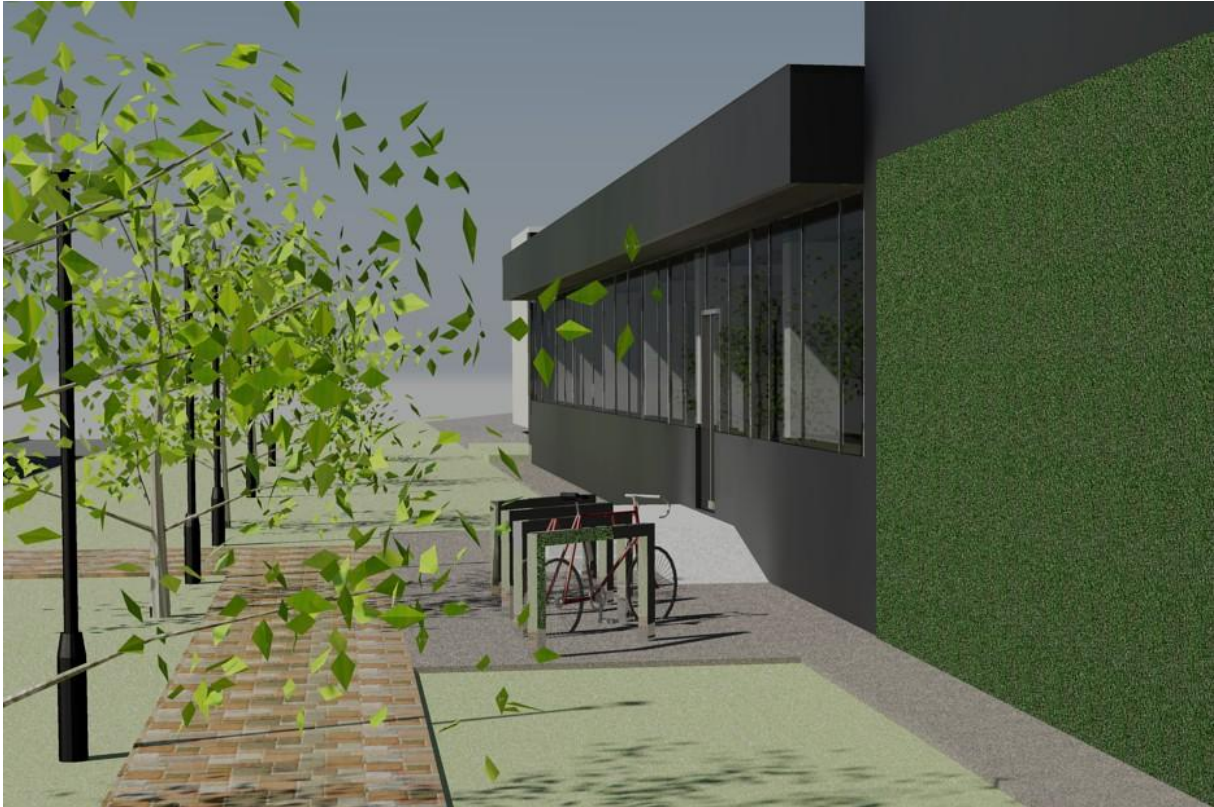
23. figure: Bird view from South-West, B variant

24. figure: Bike racks and south facade, B variant

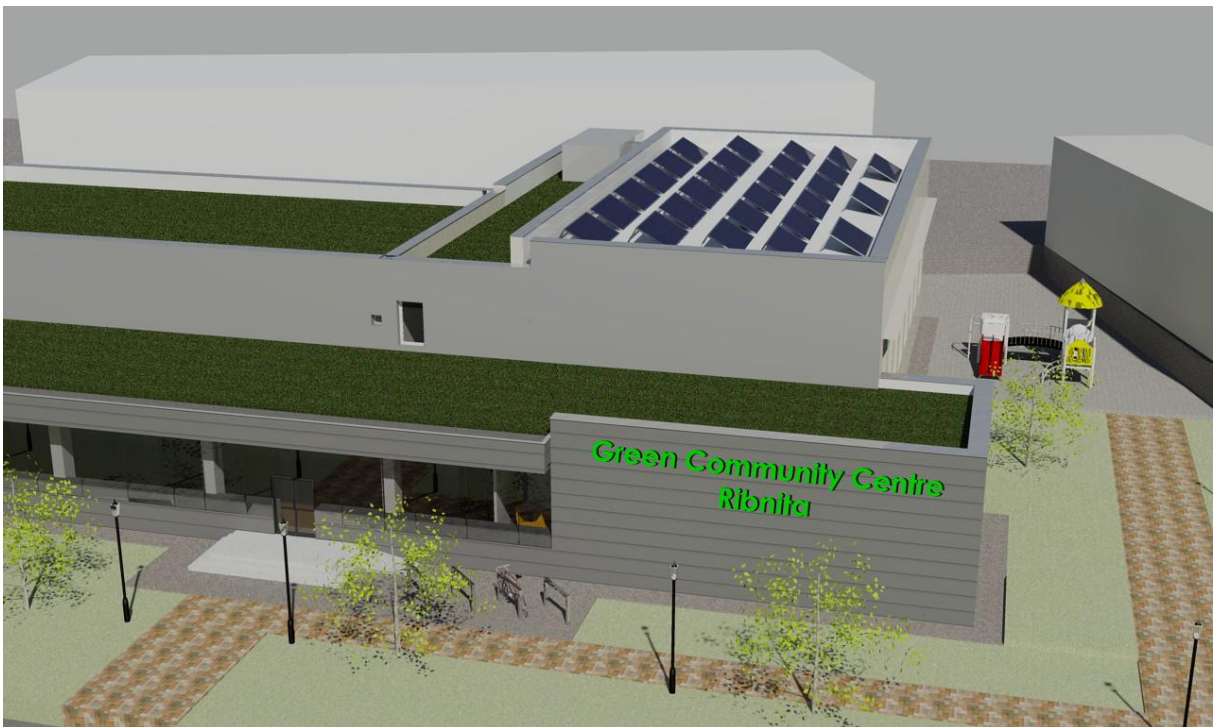
25. figure: Bird view from West, playground, C variant

26. figure: Roof view, C variant

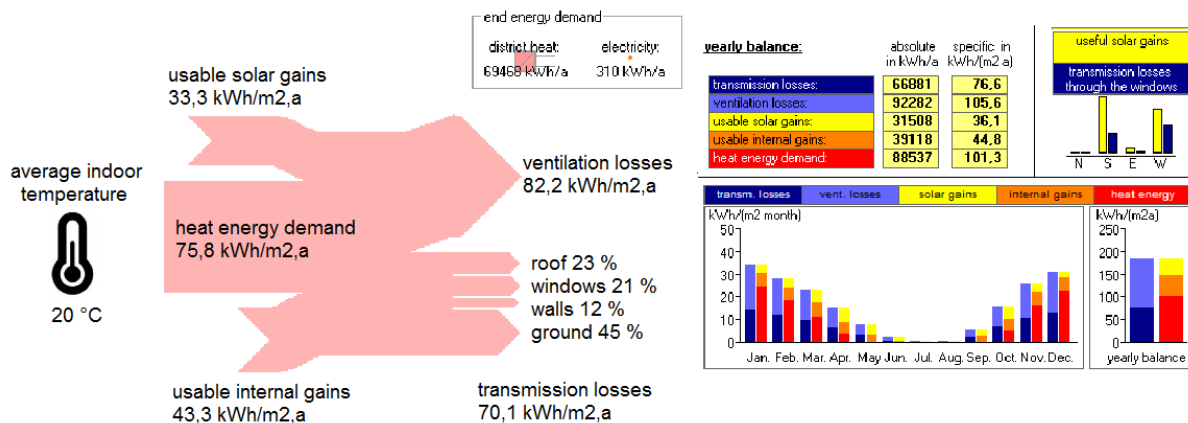
In the case of variant C we've chosen the components having the smallest possible environmental effect and utilized many comfort-increasing and aesthetical interventions during the building's reconstruction. In order to reduce the utility cost even more, the complete replacement of the building services is done, while the ventilation of the community areas and the theatre hall is solved using a periodically operated heat recovery ventilation. Due to the artificial ventilation installed, the buildings heat losses through ventilation are diminished even with respect to the other two variants, while the transmission heat losses slightly decrease because of the extensive green roof and the triple-layer windows. The extra energy demand generated by the artificial ventilation system is compensated by the installation of greater capacity solar cell system on the roof.

29. figure: Simulated energy flows of th C variant
